# Smart Textile Reinforced Concrete Sensory Structures

## SMART TEXTILE REINFORCED CONCRETE SENSORY STRUCTURES

### ABSTRACT

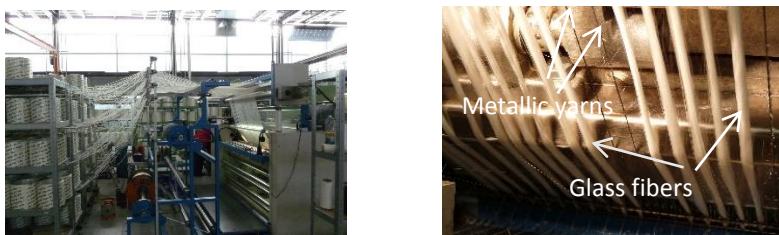
Figure1: Conductive thread insertion into warp knit.

The production of the multi-material textile is illustrated in Figure 1. The production process was not involved with any modifications in terms of tribology or tension control of the fibers. This demonstrates that the embedment of the sensory agents by their implementation as an additional component of the textile does not introduce significant complexity to the textile manufacturing procedure. The layout of the textile was designed to assure its suitability for application as reinforcement for TRC elements. These two aspects demonstrate that the conversion of the textile into a sensory one does not necessitates significant changes to the conventional procedures, either for the textile itself or for the textile reinforced concrete (TRC) member element. Correspondingly, the cost associated with the conversion into a sensory system is not expected to be a significant factor.

The sensory textile combines tows made of glass fibers and yarns made of stainless steel ([1], [8]). The glass tows, which are organized in a warp knitted grid structure with a mesh size of 7-8 mm, are the main reinforcement platform. The stainless steel fibers are embedded in that main reinforcement layer. At the same time, the stainless steel yarns are used as the sensory agent. The density of the glass fiber tows is 2,400 tex and it is made of alkali resistant (AR) glass fibers. The properties of the tows are: specific mass=2,680 kg/m<sup>3</sup>, modulus of elasticity=72 GPa, tensile strength=1,700 MPa. The equivalent diameter equals 1.06mm. The metallic yarns are made of stainless steel 12μm filaments in two twisted yarns (275X2), 75 N maximum load, 14 Ohm/m resistance, and maximum strain of 10%.
